Study on the CBN Tool Wear Mechanism on Dry High Speed Turning for AISI 4140

This study aims to investigate tools wear and wear mechanisms when machining high-rate extreme minimum lathe AISI 4140 material in hard and dry cutting conditions. Cutting tool made from CBN CB7015 Sandvik Coromant production is used for turning of AISI 4140 steel in order to obtain the failure mode of tool and the wear mechanism of the cutting tool. The machining process is carried out under dry cutting conditions with variations of high velocity Vc, feeding rate f, and a cutting depth a at minimum rate conditions. The wear growth curve obtained shows that the CBN tool undergoes three phases: the initial phase, the gradual phase, and the abrupt phase. From the results of the study found that the failure modes that occur are flank wear, crater wear, flaking, chipping, and fracturing catastrophic failure. The wear mechanism that occurs in outline is caused by abrasive, adhesive, and diffusion processes. While the cracks and fractures that occur due to a combination of impact load and thermal shock

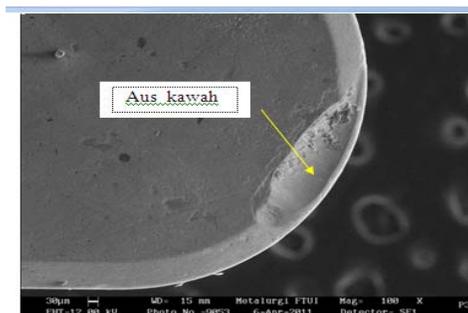
Figure 7. Chisel Display At $V = 200$ m / min ($f = 0.15$ mm / rev; $a = 0.3$ mm)

- (a) Sculptural View From Front View
- (b) Chisel Display From Top View
- (c) Chisel Display From Top View
- (d) EDS View From Top View

4140 materials are: wear side, crater wear, flaking, chipping, cracking, and fracturing. Based on the observation result of wear which happened at cutting condition 0,3 mm and rate of feeding 0,1 mm / rev, it is seen that CBN CB1515 tool failure mode at cutting rate $V = 200$ m / min is in the form of wear side (flank wear) crater wear, and flaking (Figure 6). At a feed rate of 0.15 mm / rev, it appears that CBN CB1515 failure mode at cutting rate $V = 200$ m / min is in the form of wear side (flank wear), fracture, and flaking (Figure 7).

At the rate of cutting rate $V = 200$ m / min ($f = 0.15$ mm / rev, $a = 0.3$, chisel 2 number 4) from SEM photo observation seen friction between the flow of the workpiece material in the field of growling and the main area of the chisel causing large loads received so large that there is fracture with flaking. This condition occurs due to the inconsistent load received by the chisel.

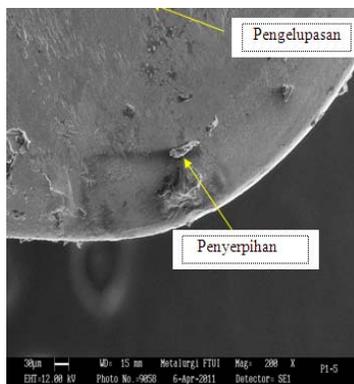
Figure 8. The chisel display at $V = 225$ m / min ($f = 0.1$ mm / rev; $a = 0.7$ mm)

- (a) Chisel view from the front view
- (b) Chisel view of the top view
- (c) Chisel view of the upper view

At cutting speed $v = 225 \text{ m / min}$ ($f = 0.1 \text{ mm / rev}$, $a = 0.7 \text{ mm}$, chisel 1, number 5) it is seen that the wear occurs at the cutting edge of the nose field although not very visible (Figure 8). The adhesion force in this condition leads to chipping, which is the occurrence of a buildup of newly formed material layers and attached around the main plane and the field of infurcation.
